**Appendix A**  
**Shell Martinez Refinery**  
**EPA Inspection Photograph Log**

### Photograph Log

**Region 9 Enforcement Division  
75 Hawthorne Street  
San Francisco, CA 94105  
Shell Martinez Refinery Photographs  
(referenced in EPA's inspection report)**

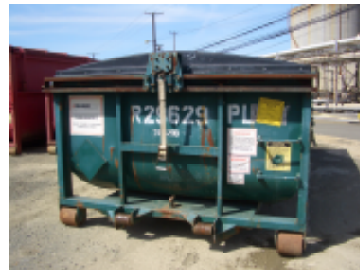
CIMG2387.JPG

CIMG2378	20 cubic yard roll-off bin located at Shell's Bin Storage Yard. The red container on the left was marked as "Designated Waste" and the container on the right was labeled as "Hazardous Waste". This area was treated as a less than 90 day hazardous waste accumulation area (HWAA).
CIMG2379	Close-up of the label shown in photo CIMG2378 in Shell's Bin Storage Yard HWAA.
CIMG2380	Close-up of the label shown in photo CIMG2378 in Shell's Bin Storage Yard HWAA.
CIMG2381	Close-up of a label on a roll-off container in Shell's Bin Storage Yard HWAA.
CIMG2382	Excluded recyclable material roll-off container in Shell's Bin Storage Yard HWAA.
CIMG2383	Overview of containers in Shell's Bin Storage Yard HWAA.
CIMG2384	Overview of containers in Shell's Bin Storage Yard HWAA.
CIMG2385	Overview of containers in Shell's Bin Storage Yard HWAA.
CIMG2386	Overview of containers in Shell's Bin Storage Yard HWAA.
CIMG2387	Overview of containers in Shell's Bin Storage Yard HWAA.

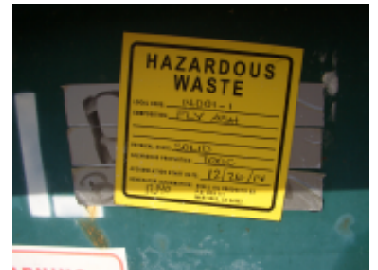
CIMG2388.JPG

CIMG2388	Hazardous Waste roll-off container in Shell's Bin Storage Yard HWAA.
CIMG2389	Close-up of the label shown in CIMG2388 in Shell's Bin Laydown Yard.
CIMG2390	Gates at Shell's 90 Day Drum Storage Area HWAA.
CIMG2391	Gates at Shell's 90 Day Drum Storage Area HWAA.
CIMG2392	Equipment located outside of Shell's 90 Day Drum Storage Area HWAA.
CIMG2393	Close-up of fire extinguisher certification tab. Note that the extinguisher has not been certified for 2015.
CIMG2394	View of extinguisher shown in CIMG2393.
CIMG2395	View of extinguisher shown in CIMG2393.
CIMG2396	Electrical Laydown Yard where PCB transformers were once stored.
CIMG2397	Electrical Laydown Yard where PCB transformers were once stored.
CIMG2398	Storm water monitoring point 4.
CIMG2399	Clean Fuels sump.
CIMG2400	Clean Fuels sump.
CIMG2401	Clean Fuels sump.
CIMG2402	Overview photo of Clean Fuels sump.
CIMG2403	Overview photo of Clean Fuels sump.

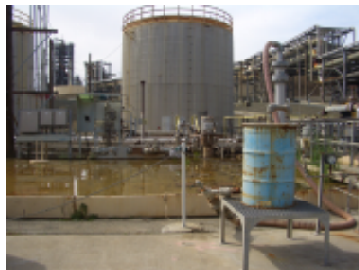
CIMG2405.JPG

CIMG2404	Overview photo of Clean Fuels sump.
CIMG2405	Hazardous waste container located in the Clean Fuels area. Inspectors noted that this container was left open at the time of the inspection with no personnel present. Shell personnel closed this container during the inspection.
CIMG2406	View of the gross oil separator (GOS). The liquid is on top of the GOS.
CIMG2407	Same view of CIMG2406. Note the blue carbon canister used to treat the vented VOCs.
CIMG2408	View of the upper end of the GOS.
CIMG2409	View of the lower end of the GOS.
CIMG2410	View of the GOS. In the background of this photo is a wastewater sampling collection point.
CIMG2411	Blue carbon canister used to treat the vented VOCs.
CIMG2412	Excluded recyclable material tank. The ERM label had been obliterated at the time of the

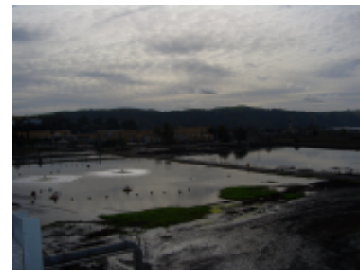
CIMG2432.JPG

CIMG2432	View of the pond 5D. Note the limited freeboard.
CIMG2433	View of the pond 5E.
CIMG2434	View of the pond 5E.
CIMG2435	Oily staining on the grounds at the selenium treatment area. Note the accumulated kitty litter, indicating that previous spills had not been completely addressed.
CIMG2436	Solids skimmer at the selenium treatment pond.
CIMG2437	GAC backwash discharging into pond 5D.
CIMG2438	Crack in the asphalt at the selenium treatment area.
CIMG2439	Oily staining and cracks on the grounds at the selenium treatment area.
CIMG2440	Oily staining at the selenium treatment area draining into pond 5D.
CIMG2441	Perimeter of Pond 8 at the selenium treatment area.
CIMG2442	Perimeter of Pond 8 at the selenium treatment area. Note the GAG unit in the background.
CIMG2443	View of Pond 5C2.
CIMG2444	View of Pond 5E which receives influent from EPT2 and EPT3. Note the selenium treatment plant in the center-right of the photograph.

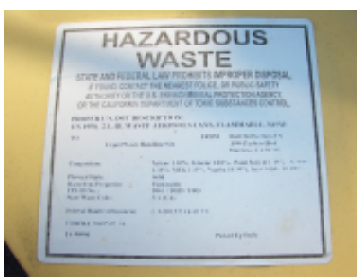
CIMG2462.JPG

CIMG2461	Label on a satellite container shown in CIMG2460.
CIMG2462	Label on an aerosol can satellite container shown in CIMG2460.
CIMG2463	Close up of a satellite container shown in CIMG2460.
CIMG2464	View of the area shown in CIMG2460.
CIMG2465	Label on F037 waste in a roll-off container located at the API separator area. This area is subject to the 90 day accumulation area requirements and was not identified by Shell as a HWAA.
CIMG2466	Former permitted hazardous waste storage tank 12038. The tank is currently used to hold bio treater waste.
CIMG2467	EPT1, also named Pond 7.
CIMG2468	EPT1 primary clarifier box.
CIMG2469	EPT1 primary clarifier box.
CIMG2470	EPT1 pond aerator.
CIMG2471	Shaker solids (F037, F038, K050, K051) from the liquid waste handling site. Reportedly, the liquid in the container was from a recent rain event, according to Shell personnel.
CIMG2472	Side view of the container shown in CIMG2471.

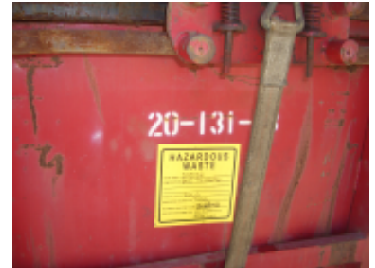
CIMG2488.JPG

CIMG2488	20 cubic yard roll-off of RCRA-hazardous waste solids at the Recovered Oil Unit.
CIMG2489	Close up label on the 20 cubic yard roll-off of RCRA-hazardous waste solids at the Recovered Oil Unit.
CIMG2490	View of carbon monoxide boiler (COB) 3.
CIMG2491	Baghouse unit for fly ash (K048 and D010.) Note the accumulated regulated fly ash on the wooden structure beneath the baghouse.
CIMG2492	25 Super Sacks (one cubic yard each) of waste fly ash (K048 and D010.) This is another Less Than 90 Day HWAA not identified by Shell.
CIMG2493	Photo of the heat exchanger bundle cleaning east pad area. A PSC vacuum truck was being cleaned out during the inspection. Solids with an unknown waste classification were observed beneath the PSC truck.
CIMG2494	West trench drain at the heat exchanger bundle cleaning pad area. Note the solids mixed with K050 waste in the drain. Also note the deteriorated concrete in the lower portion of the photo.

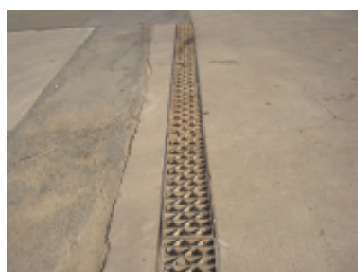
CIMG2495.JPG

CIMG2495	Central trench drain at the west pad heat exchanger bundle cleaning pad area. Note the solids mixed with K050 waste in the drain.
CIMG2496	Central trench drain at the west pad heat exchanger bundle cleaning pad area. Note the solids mixed with K050 waste in the drain. Note the pavement cracks on the right portion of the photo.
CIMG2497	Three cleaned bundle units situated over the center trench. The steam cleaning unit is at the center right of the photograph. The east trench is located in the far right of the photograph. This photo was taken facing southwest. Note the several large cracks in the pavement.
CIMG2498	Close up view of the center trench drain near the steam cleaning unit. Note the accumulated the solids mixed with K050 waste sticking to the metal.
CIMG2499	Close up view of the center trench drain near the steam cleaning unit. Note the accumulated the solids mixed with K050 waste.

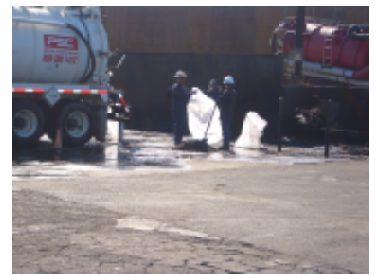
CIMG2500.JPG

CIMG2500	Overview photo of the west bundle cleaning pad.
CIMG2501	Photo of the heat exchanger bundle cleaning pad area. A PSC vacuum truck was being cleaned out during the inspection. Solids with an unknown waste classification were observed beneath the PSC truck.
CIMG2502	Fire extinguisher at the Central Waste area. The last inspection date was September 16, 2011.
CIMG2503	Eye wash station at Central Waste. Note that only non-RCRA hazardous waste was stored at this location.
CIMG2504	Contents of a 40 cubic yard roll off container of oily waste at Central Waste.
CIMG2505	Overview photo of the container shown in CIMG2504.
CIMG2506	Label on the container shown in CIMG2504.
CIMG2507	Leaking material coming from container shown in CIMG2504.
CIMG2508	Dumped solid waste adjacent to Central Waste.
CIMG2509	Overview of Central Waste area. Photo was taken facing north.
CIMG2510	½ cubic yard of unknown solids in a 20 cubic yard roll-off container at the empty container storage area (PSC135).

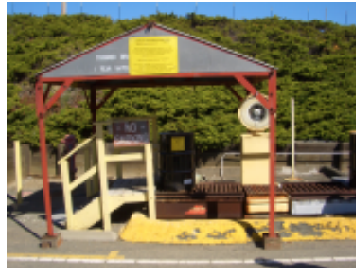
CIMG2511.JPG

CIMG2511	Outside view of the container shown in CIMG2510.
CIMG2512	View of the hazardous waste satellite collection area at Shell's Insulators and Paint Shop. Note the partial view a 55 gallon container of solvent waste which had been designated for transfer to the Liquid Waste Storage Area since March 11, 2015 located on the far right of the photo (in transit to the HWAA for over 3 days).
CIMG2513	Fire extinguisher inside the Insulators and Paint Shop.
CIMG2514	Universal waste batteries collection container in the Insulators and Paint Shop.
CIMG2515	Sandblast pad area operated by Brand. Numerous containers of solvent (D001 and/or D035, F003) and aqueous-based paint waste were left open to dry. Note that DTSC's air monitor detected over 1 ppm VOCs at this area.
CIMG2516	Top view of the containers shown in CIMG2515.

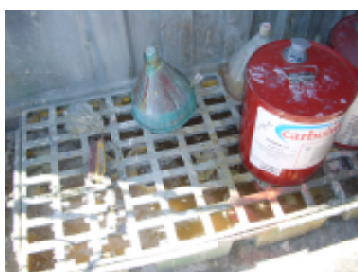
CIMG2517.JPG

CIMG2517	View inside the middle paint locker at the sandblast pad area operated by Brand. Note the empty paint thinner containers being stored on secondary containment pads.
CIMG2518	Secondary containment pad pictured in CIMG2517. Note the secondary containment was nearly full and had limited freeboard.
CIMG2519	Hazardous waste container in the back of the middle locker in the sandblast pad area operated by Brand. Note that the container was not labeled.
CIMG2520	View of the warning label on one of the containers shown in CIMG2515.
CIMG2521	View of the warning label on one of the containers shown in CIMG2515.
CIMG2522	Universal waste container at the Recycling Center.
CIMG2523	Contents of the container shown in CIMG2522.
CIMG2524	Universal waste container for ballasts at the Recycling Center. None of the ballasts contained PCBs.
CIMG2525	Universal waste container for ballasts at the Recycling Center. None of the ballasts contained PCBs.

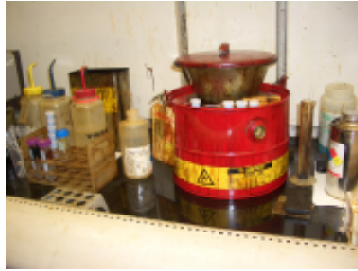
CIMG2526.JPG

CIMG2526	Universal waste container for "ballasts" at the Recycling Center. EPA believed these objects were capacitors and not ballasts.
CIMG2527	6A fume hood at Shell's Quality Assurance Lab. Note the containers of xylene, acetone, toluene and hexane which are used to clean lab equipment and/or extraction of petroleum for analysis. The spent solvents are placed in the one gallon red container pictured in the center of the photo. Note that the red container was not labeled.
CIMG2528	6A fume hood at Shell's Quality Assurance Lab. There were two hazardous waste satellite collection containers in fume hood 6A. The container with a yellow label in the background of this photo was one of the two containers used to collect waste pipettes, wipes, solid and other contaminated debris. Note that both containers were not closed. Note that 15 other fume hoods had similar configurations in the Quality Assurance Lab.

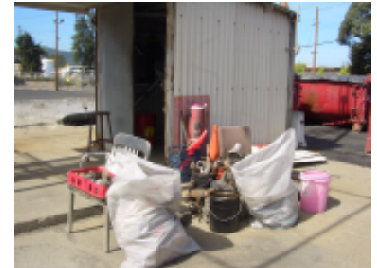
CIMG2536.JPG

CIMG2536	Open container of oily waste in the North Gate transfer area.
CIMG2537	Overview of bags of oily waste shown in CIMG2536.
CIMG2538	View of absorbant material placed on spills at the North Gate transfer area.
CIMG2539	Unlabeled and open container of unknown liquid waste that appeared to be oily waste.
CIMG2540	Several rusted containers stored in a locker in Crude Hill.
CIMG2541	Several rusted containers stored in a locker in Crude Hill.
CIMG2542	Overview photo of the locker in Crude Hill.
CIMG2543	Overview photo of the locker in Crude Hill.
CIMG2544	Discarded lamps in the locker in Crude Hill.
CIMG2545	Fume hood at the field lab located within the Crack Products Blast Resistant Module, containing
